NATIONAL BUREAU OF STANDARDS REPORT

4472

WATER VAPOR TRANSMISSION THROUGH JOINTS AND BREAKER STRIPS OF INSULATED PANELS FOR REFRIGERATED WAREHOUSE, PANEL NO. 1

NBS PROJECT		NBS REPORT
1003-20-4832	January 9, 1956	4472

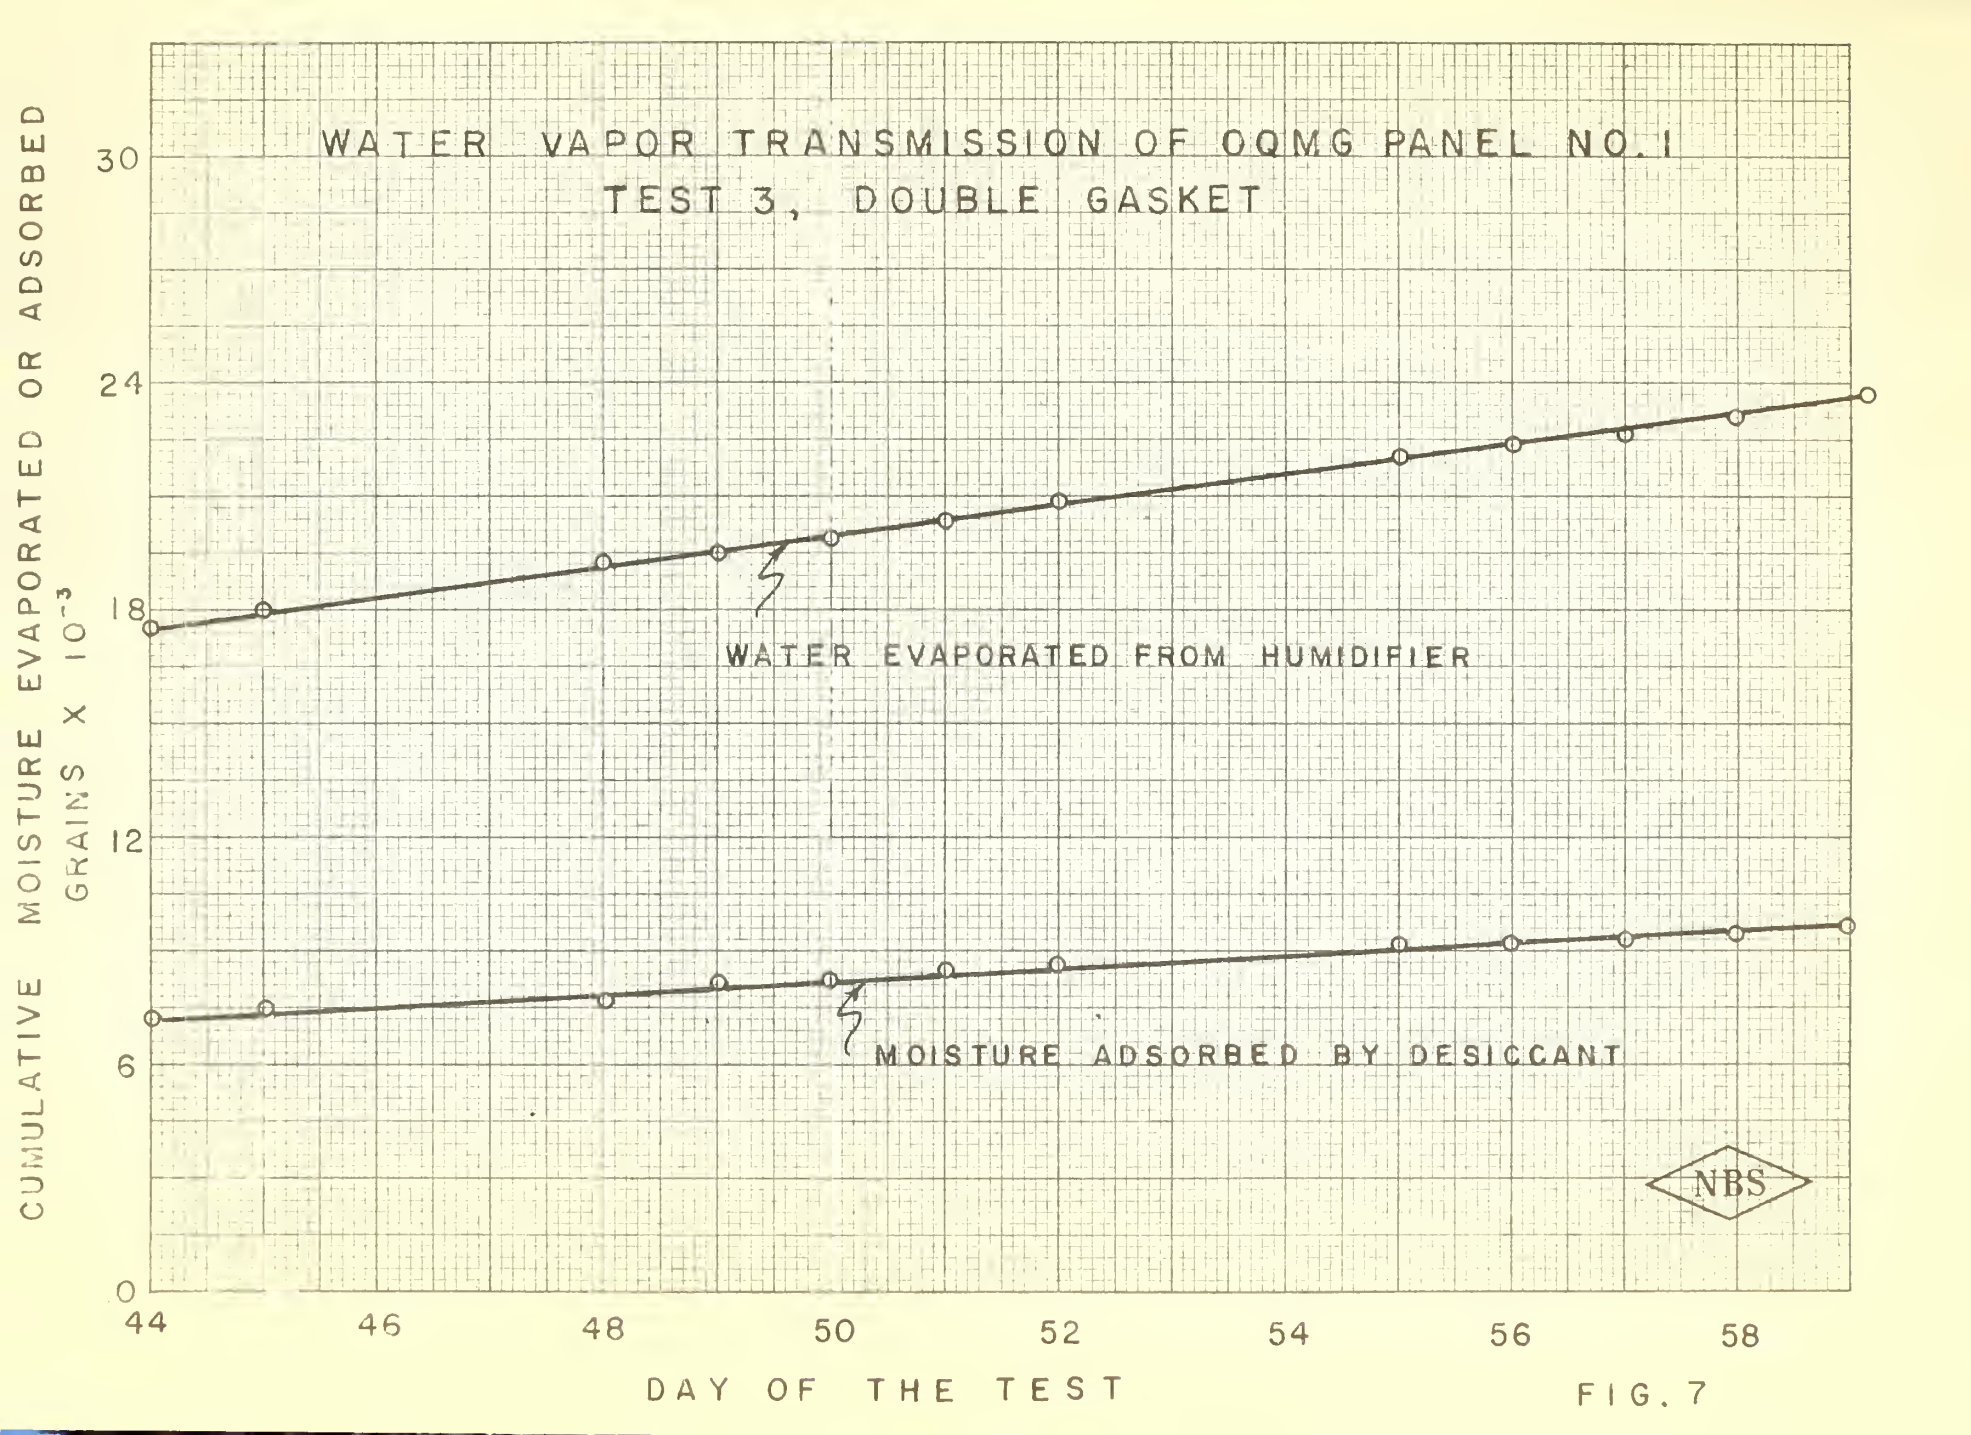
FIG. 7

Fig. 7 shows the rate of water evaporation on the warm side of the panel and the rate of moisture adsorption on the cold side of the panel on a cumulative basis for fifteen days during Test 3 when these rates were nearly steady. Conditions were not as steady for the entire 73 days as those shown in Fig. 7 because of difficulties in obtaining steady vapor generation in the humidifier. The rates of moisture transfer reported in Table 2 for Test 3 correspond to those plotted in Fig. 7. Fig. 8 shows corresponding water evaporation and moisture adsorption data for the entire duration of Test 4. This figure shows some change in water vapor transmission rates after the first eight days of the test, but nearly constant rates thereafter. The rates of moisture transfer reported in Table 2 for Test 4 correspond to those shown for the last eight days in Fig. 8.

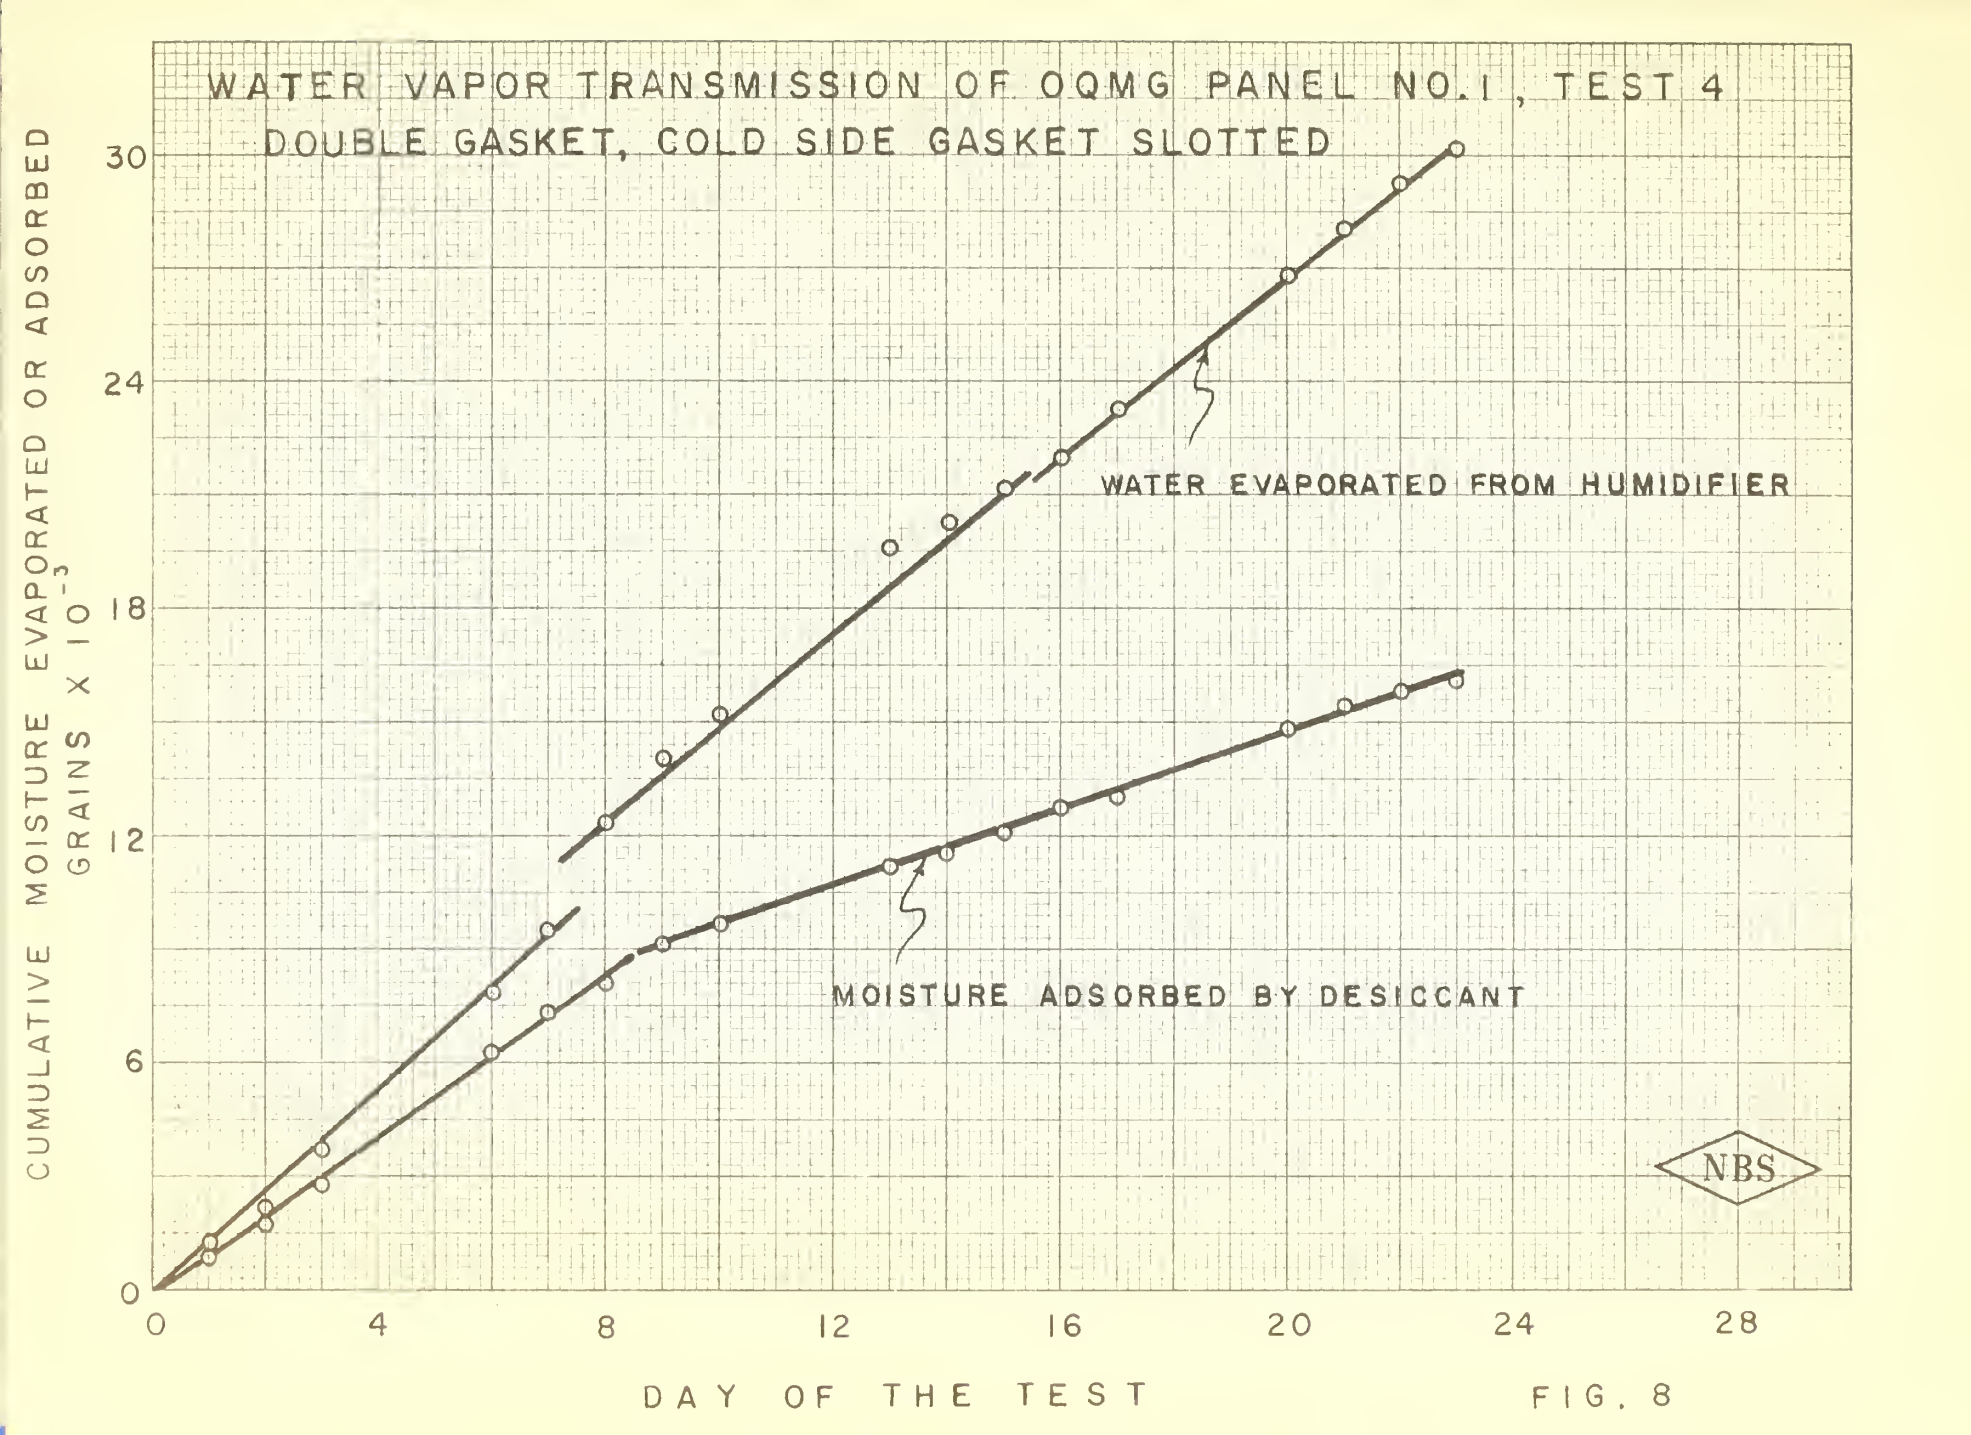
FIG. 8

vapor transmission into the insulation space. Frost was found at all five points of observation in the insulation after 23 days in Test 4 whereas condensation was not imminent after 73 days during Test 3. The vapor pressure on the warm side and the vapor pressure difference across the panel were comparable for the two tests, but the water evaporation rate required to maintain the vapor pressure on the warm side during Test 4 was about three times as high as for Test 3. The moisture adsorption rate on the cold side during Test 4 was also about three times as high as for Test 3. These results indicate that slotting the cold side gasket permitted higher overall moisture transfer through the panel joints, and also suggests that the vapor pressure in the joint itself adjacent to the wood breaker strips and panel fasteners was probably higher in Test 4 than in Test 3. The moisture content of the air in the panel joints was not measured during these tests.
